# SUMMARY REPORT

# FRP VESSEL

EQUIPMENT NAME:  
Stripper Column

PROCESS UNIT OR AREA:  
Waste Treatment Unit

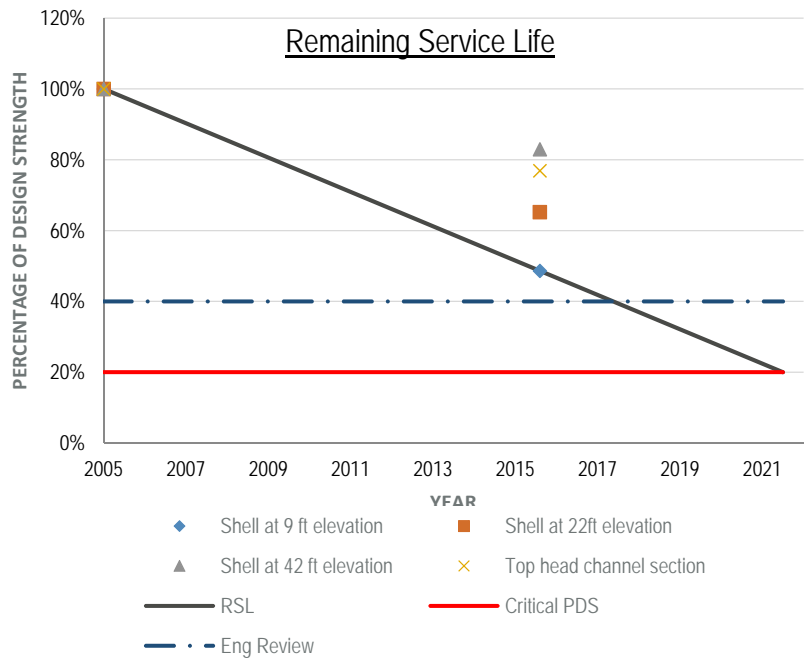
## CONCLUSIONS

- The FRP vessel is suitable for continued service to the next recommended UTComp inspection.
- Defect or damage to the support structure was detected.
- Defects or damage to the exterior of the tank was detected.
- Defects or damage to external components of the tank was detected.
- Defects or damage to pipe and nozzle connections of the tank were detected.
- Percentage of Design Strength is greater than the Critical PDS.

Action	Basis	Timing
Next UTComp evaluation	UTComp Calculations	2018
Repair corroded anchor bolts.	External Inspection	2015
Evaluate the damage to the insulation of the tank.	External Inspection	2015
Evaluate the damage to the external surface of the tank (around Nozzle A and its repad)	External Inspection	2015
Verify that all pressure relieving devices are suitable for service.	External Inspection	2015
Replace all cracked FRP Flanges (Nozzle M and Body Flange 2)	External Inspection	2015
Install supports for pipes at connections to the tank (Nozzle A piping)	External Inspection	2015
